PRESSURE-TEMPERATURE RELIEF VALVE

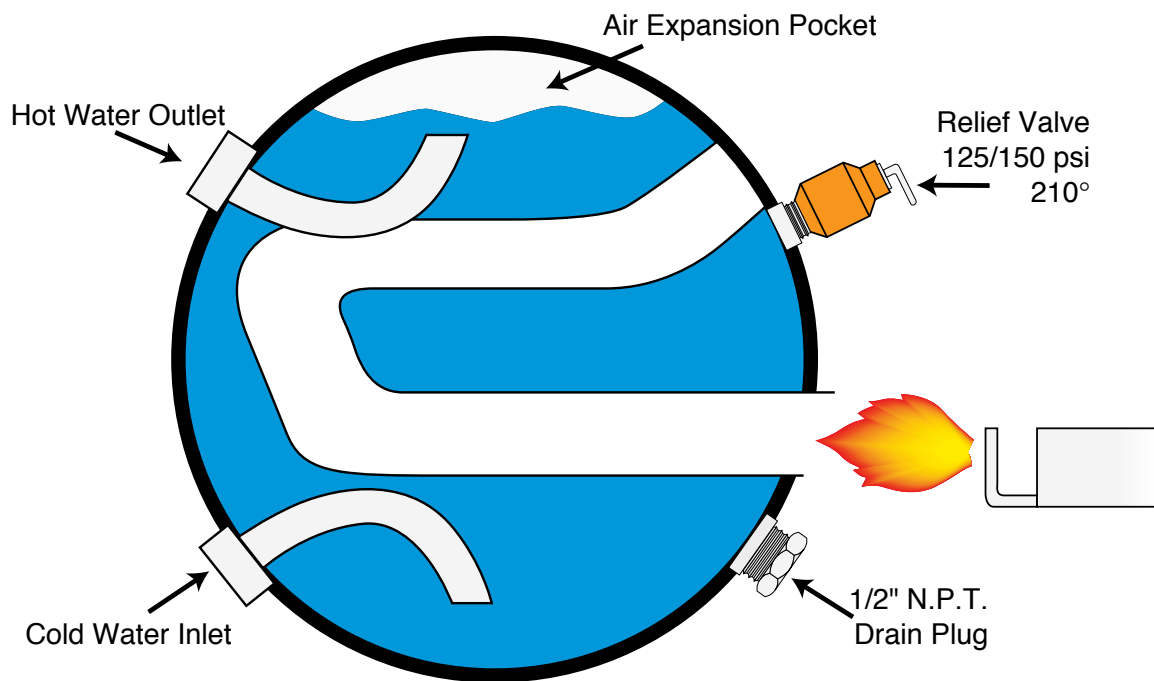
- Step 1:** Turn off water heater
- Step 2:** Turn off incoming water supply
- Step 3:** Open the closest hot water faucet in the coach
- Step 4:** Pull handle of pressure-temperature relief valve straight out and allow water to flow until it stops.
- Step 5:** Allow pressure-temperature relief valve to snap shut; close faucet; turn on water supply.

Weeping or dripping of a pressure-temperature relief valve while the water heater is running DOES NOT mean it is defective. This is normal expansion of water as it is heated in the closed water system of a recreation vehicle. The Atwood water heater tank is designed with an internal air gap at the top of the tank to reduce the possibility of weeping and dripping. In time, the expanding water will absorb this air. To replace the air follow these steps:
